General Information on Florida's Cattle Dip Vats

Florida's Cattle Dip Vats

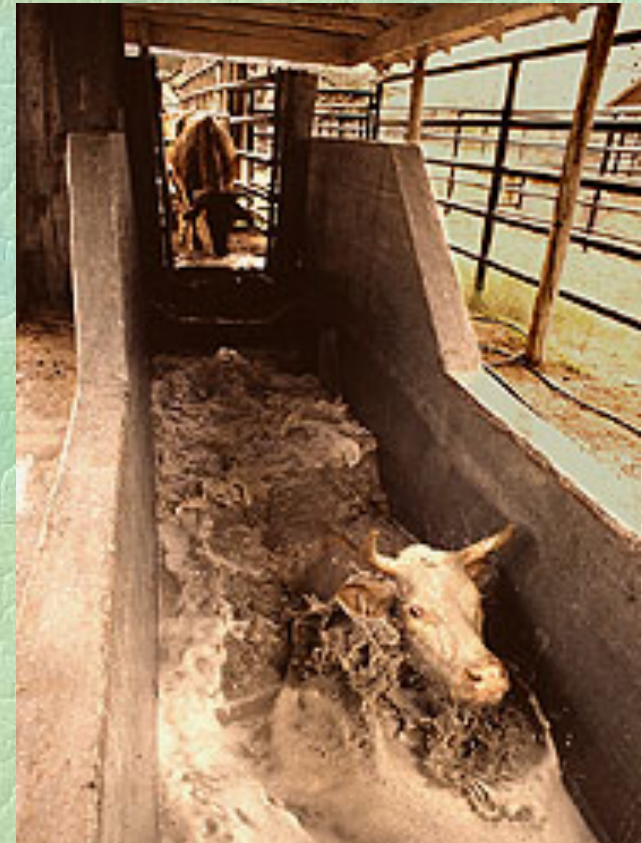
- ❓ Vats typically consisted of a long, narrow subsurface trough with concrete walls that extend about 3 feet above the ground that were filled with chemicals to remove ticks.

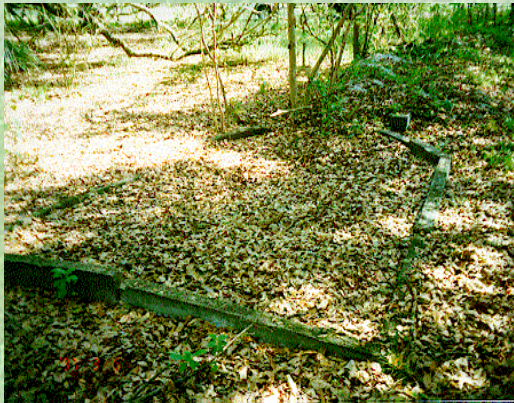
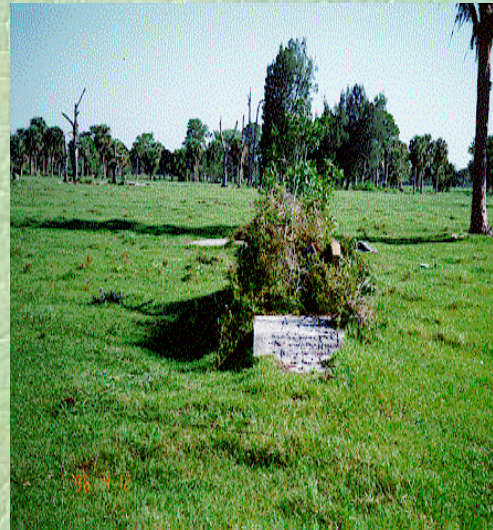
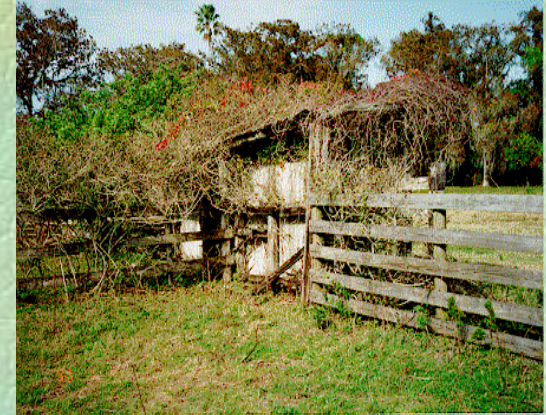
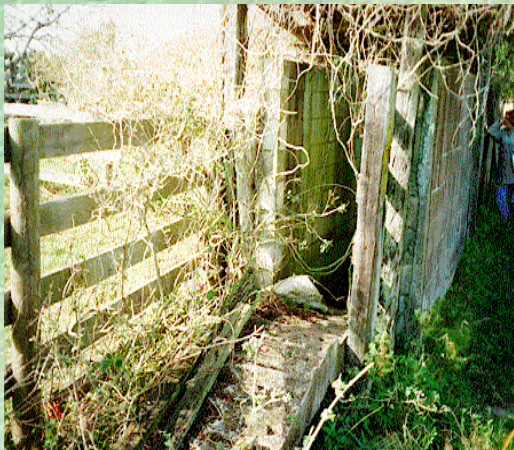
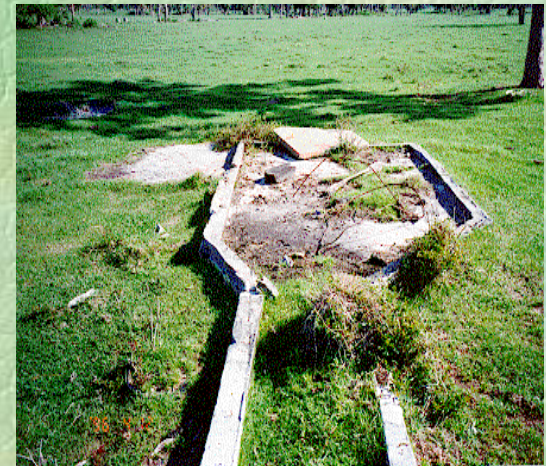
- ❑ The majority of the vats are dismantled or undistinguishable, especially with land use changes. However, a few are still visible, as the below pictures indicate:

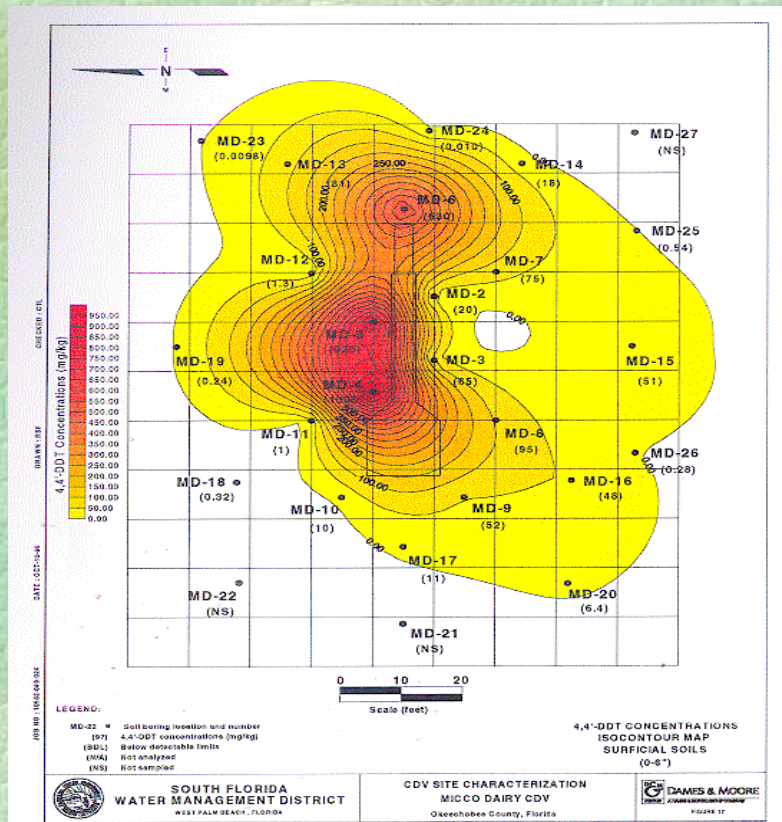
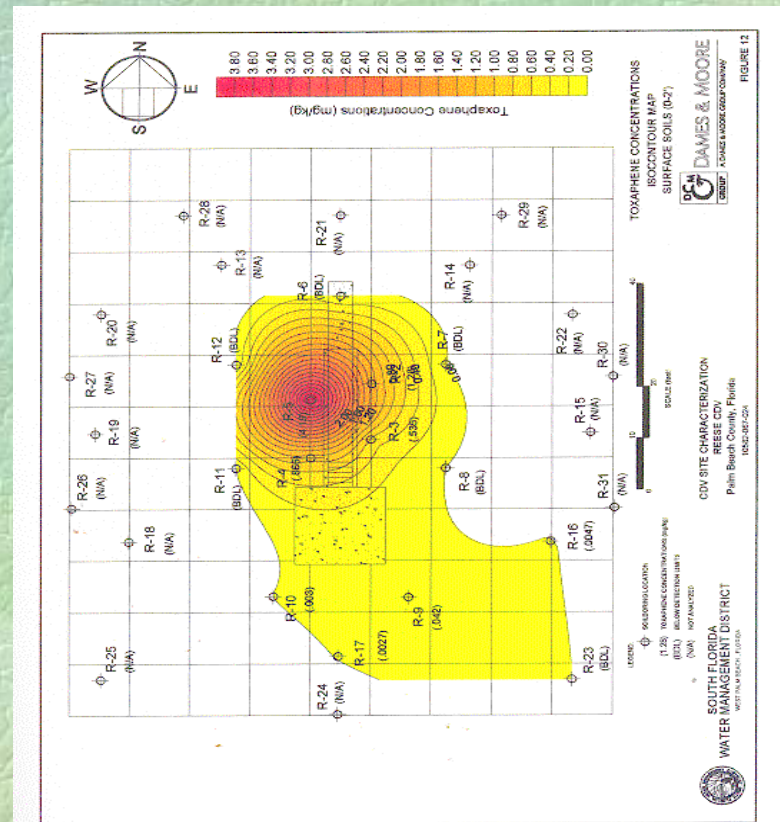
Chemicals in the soils in and around the cattle vats have been found to move in plumes 100 - 150' in any direction as shown in the two examples below:
